PROPERTY INSPECTION REPORT

123 Anywhere, Texas

Steven L. Reeves Lic # 9219

10/29/2009

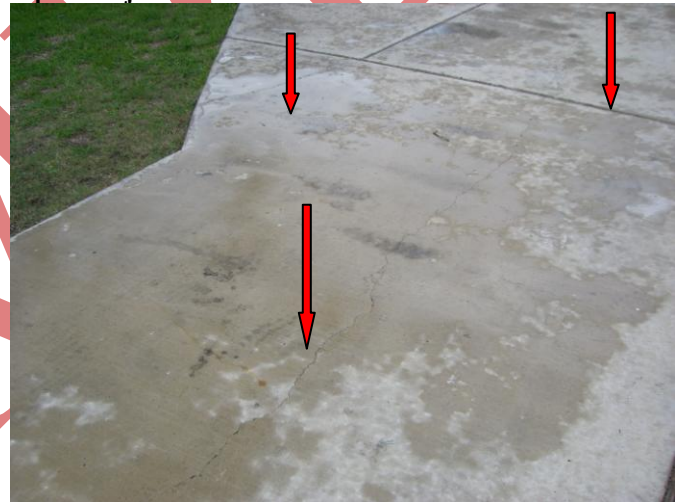
17 **Driveway**

Driveway has settlement cracks. Recommend sealing expansion joints with elastomeric caulk

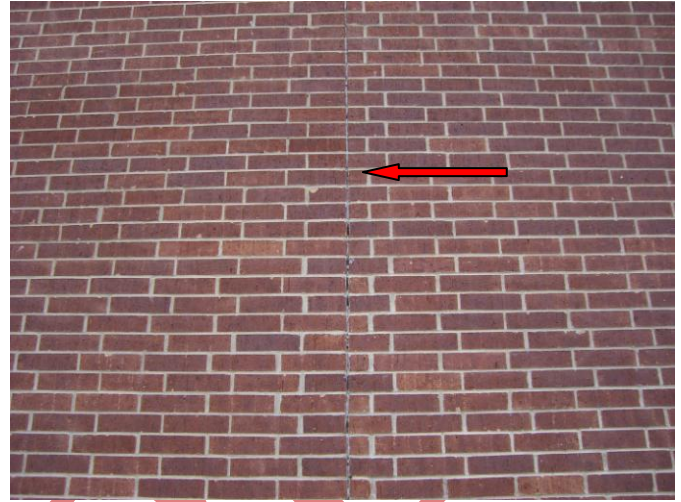
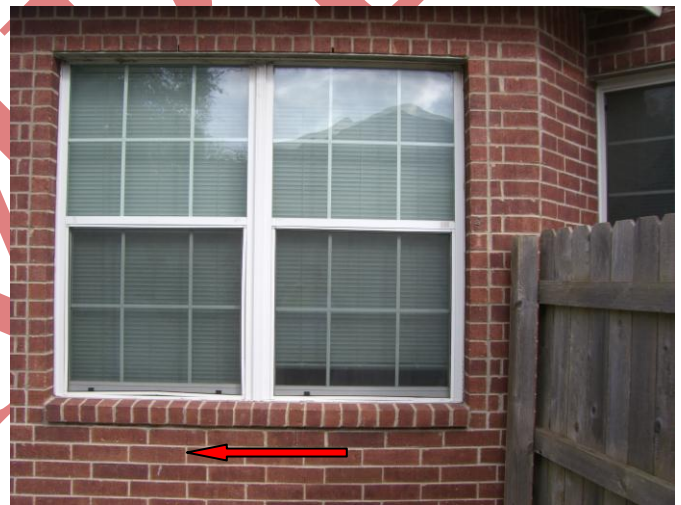
20 Walls

Expansion joints at Brick Veneer are showing signs of needing re-caulked. Settlement crack on bay window in the brick veneer needs to be caulked and monitored.

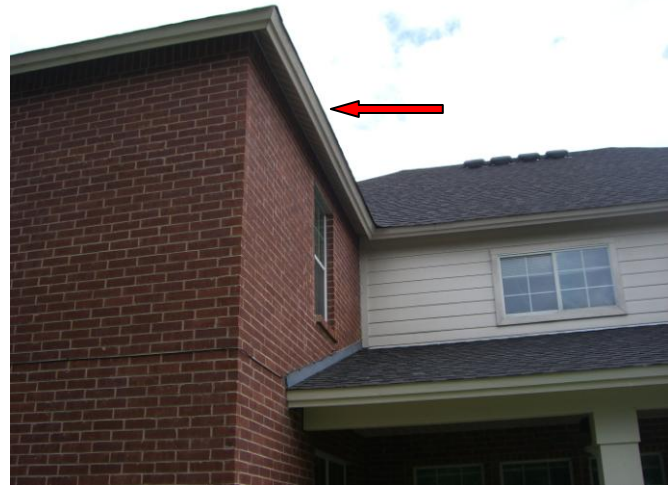
36 Flashings

No drip edge flashing on any of the freeze board.

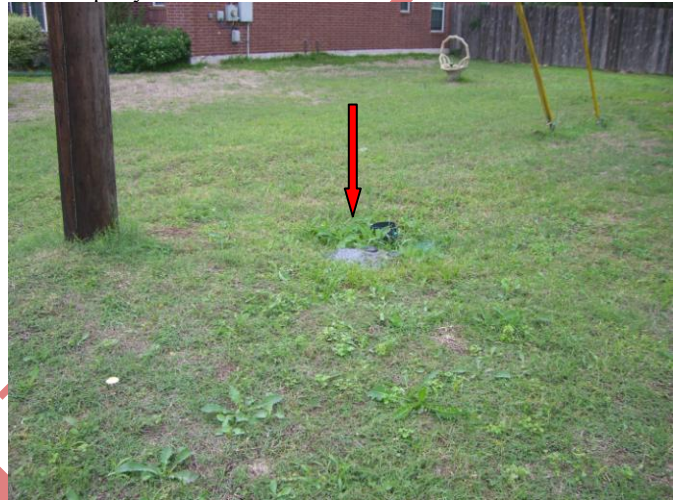
60 Main Water Service

Main water service is city utility. Water Meter located at North East Property line.

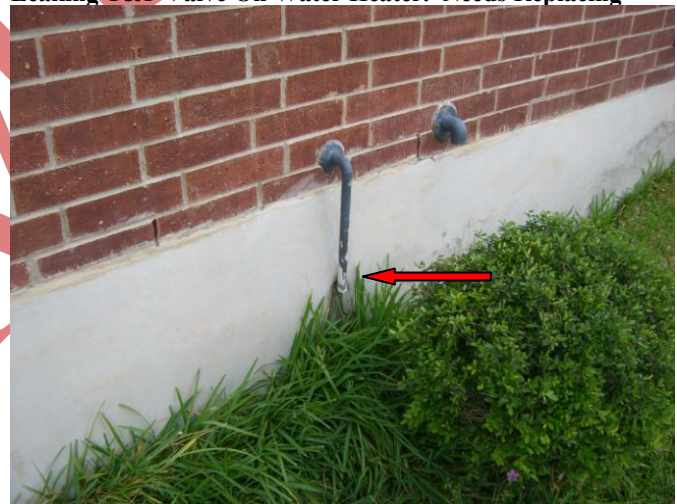
74 **Relief Valve Piping**

Leaking T&P Valve On Water Heater. Needs Replacing

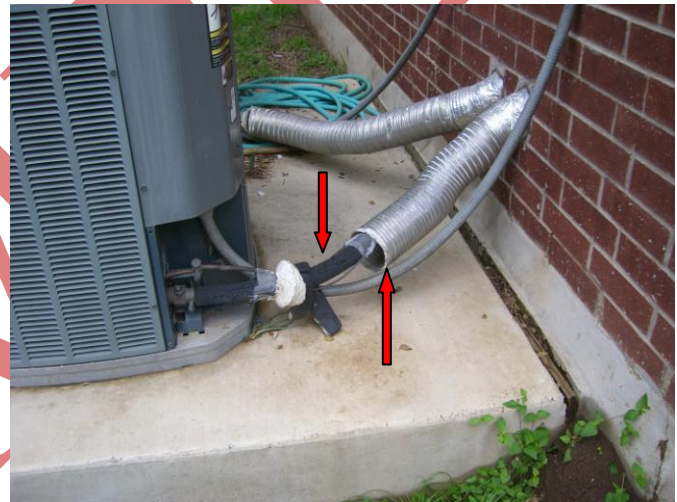
Insulation on Freon lines showing signs of replacement. The flex chase for the Freon lines needs to be re-sealed.

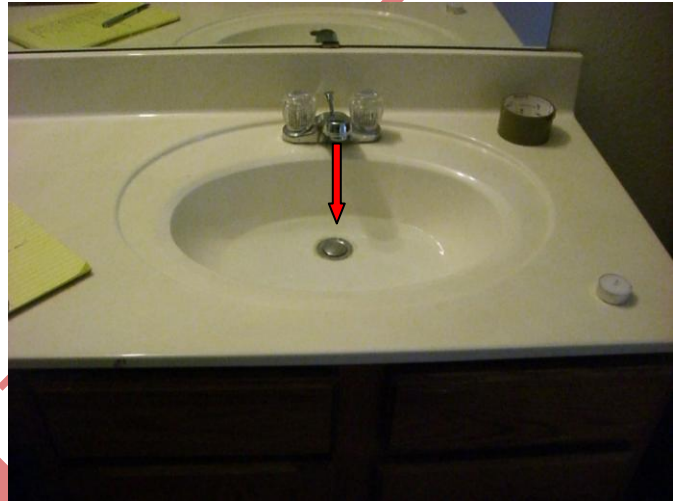
10 Sink/Basin

Double vanity with separate sinks. Right hand sink stopper will not drain water.

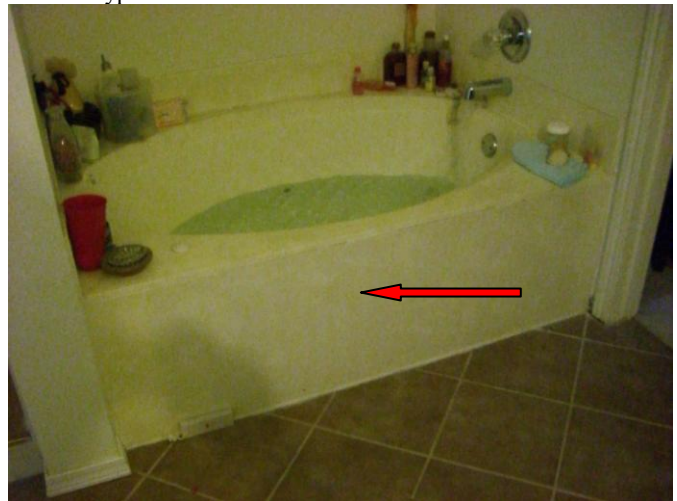
10 Garden Tub

Jacuzzi Type. Motor not accessible.

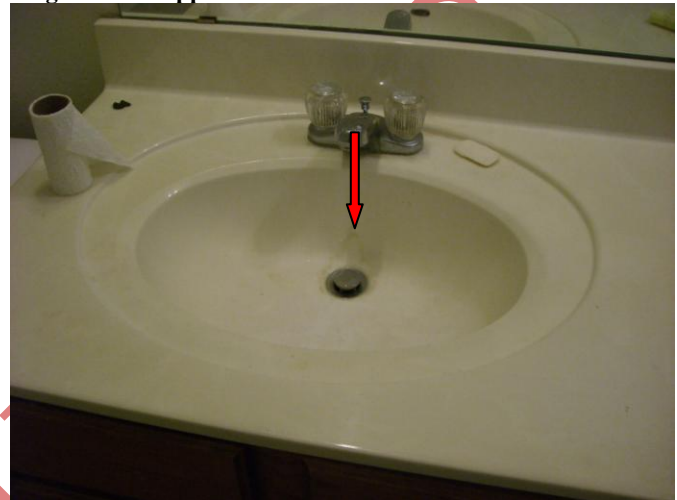
10 Sink/Basin #4

Single sink. Stopper will not hold water.

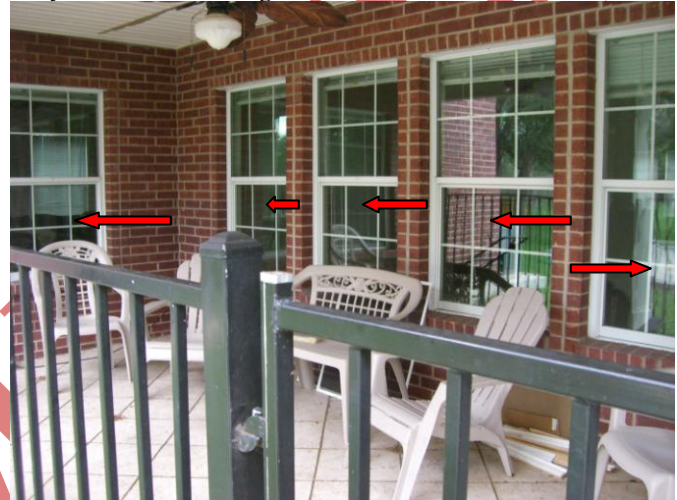
17 **Windows**

Vinyl insulated. Missing Screens several Windows

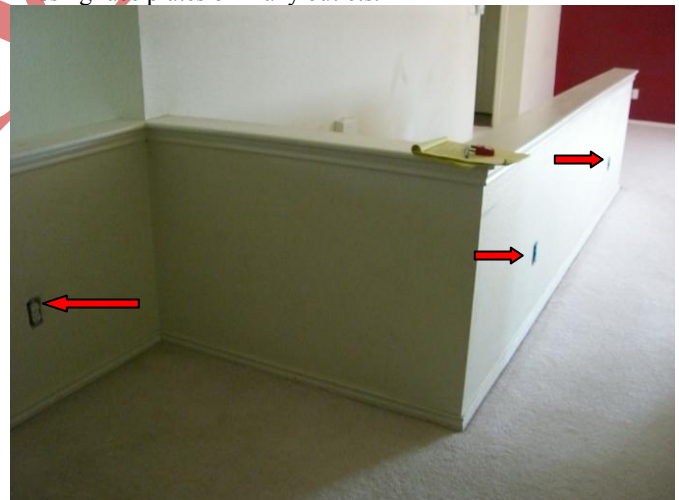
<input checked="" type="checkbox"/>	<input type="checkbox"/>	<input type="checkbox"/>	<input type="checkbox"/>	18 Doors	Masonite
<input checked="" type="checkbox"/>	<input type="checkbox"/>	<input type="checkbox"/>	<input checked="" type="checkbox"/>	18 Walls Electrical outlets/switches	Painted Drywall. Missing face plates on many outlets.

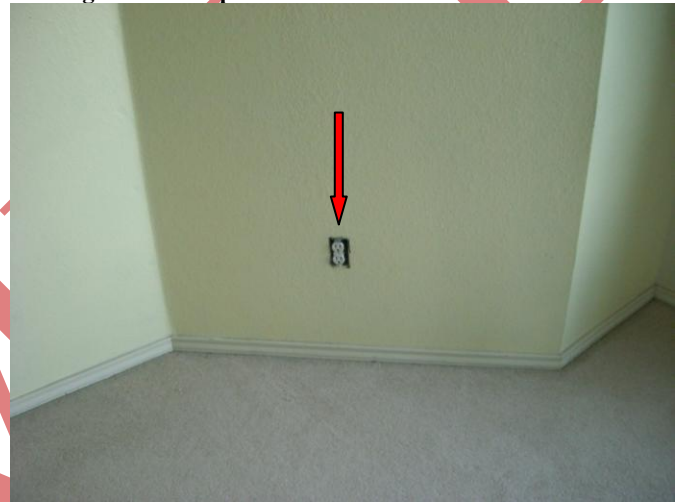
Electrical outlets/switches

Missing outlet face plate

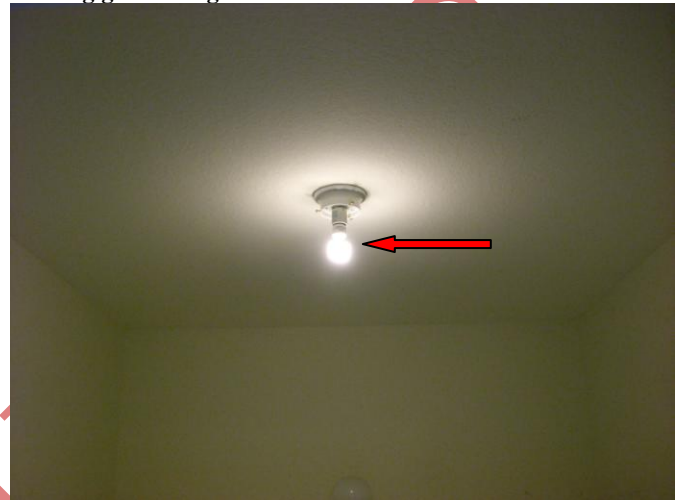
18 **Doors
Closet**

Masonite
Missing globe to light fixture

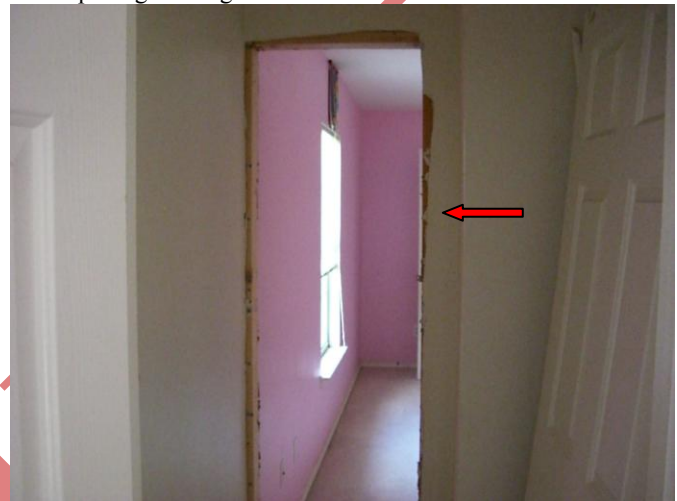
18 **Doors**
Closet

Masonite
Wall opening missing door.

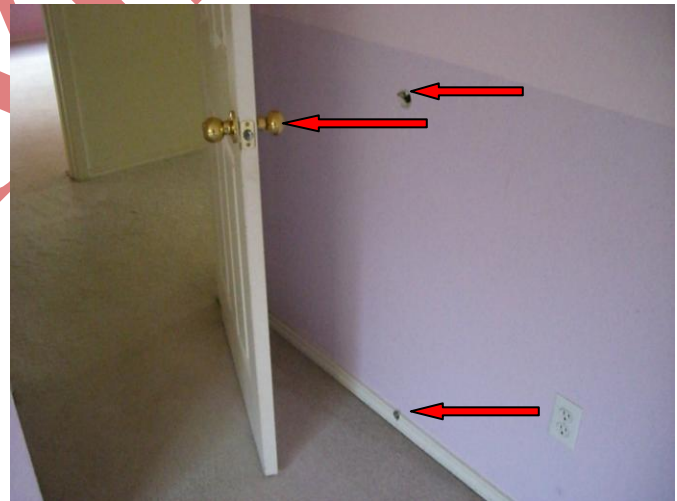
18 Doors

Masonite Door. No door stop, door won't latch. Hole in the wall behind door.

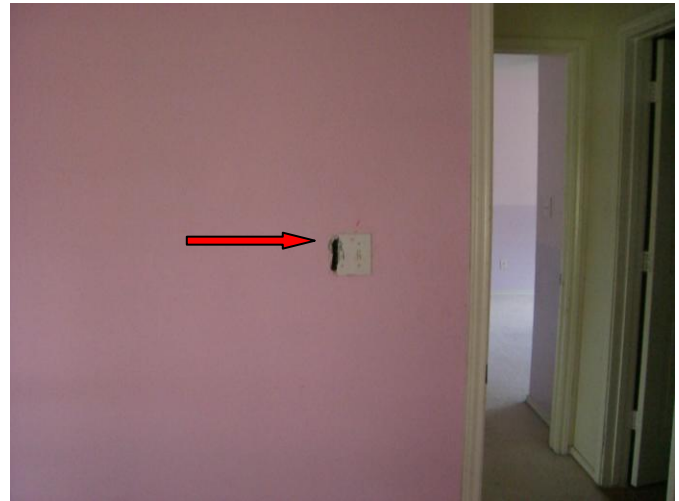
18 Walls
Electrical outlet/switches

Painted Drywall. Hole in the wall behind door.
Missing switch plate

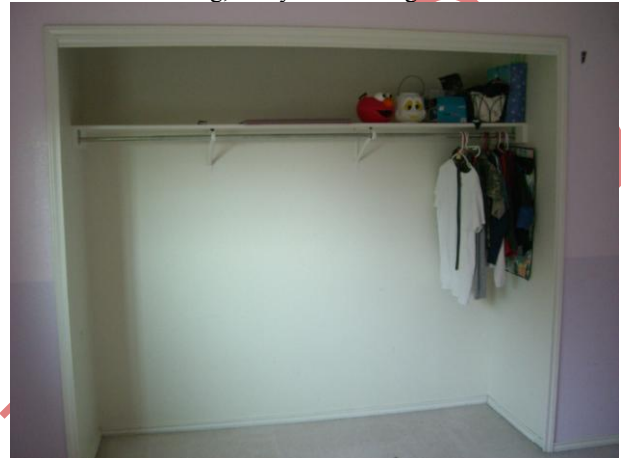
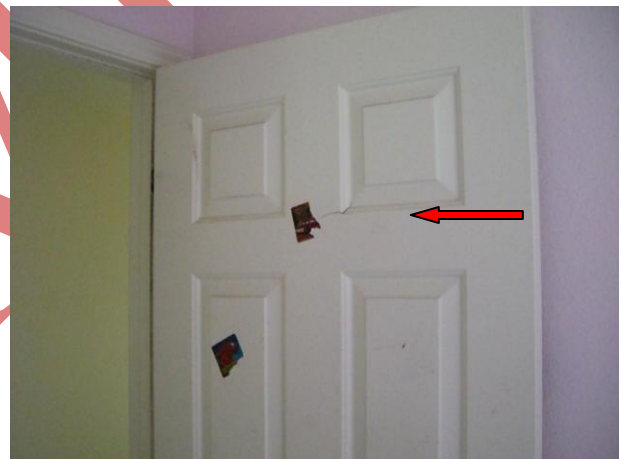
18 Doors

Closet doors missing, Entry door damaged.
